Manhole Inspection Summary

Manhole # S31G__004MH

Insp Date: **8/1/08 10:26 AM**

Location Address: **rear 405 cider al**

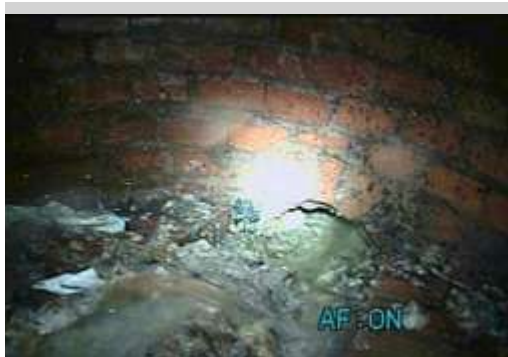
Defect 3

Condition: ☐ Sound ☐ Cracked ☐ Root Intrusion ☐ Deteriorated ☐ Leaks ☒ **Debris**

bench and channel debris

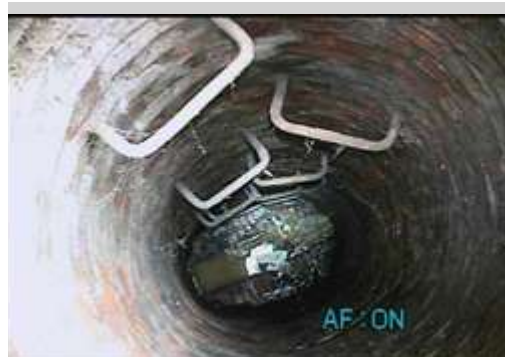
Defect 2

Steps Count: **10** Missing: **0** ☒ **Corroded**

Corroded steps

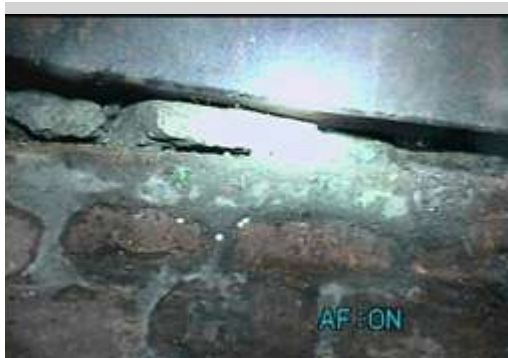
Defect 1

Condition: ☐ Sound ☐ Cracked ☐ Root Intrusion ☒ **Loose Brick** ☒ **Deteriorated**

Chimney crack during frame adj

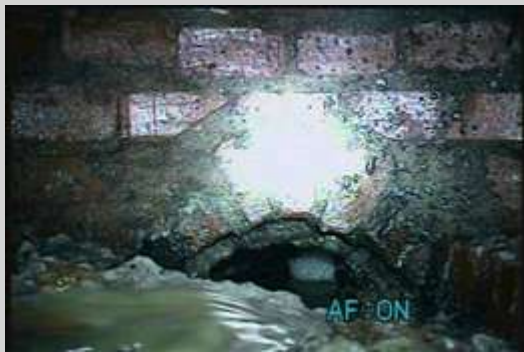
12 O'Clock Outflow

8 in. Circular Gravity Sewer
Pipe Out @ 12 O'Clock

Invert Depth: **15.20** (ft.) Flow Characteristics: **Fast**

Deposits: ☒ None ☐ Mud ☐ Sludge ☐ Debris ☐ Grease

Infiltration: **None** Pipe Seal Cond: **Unknown**

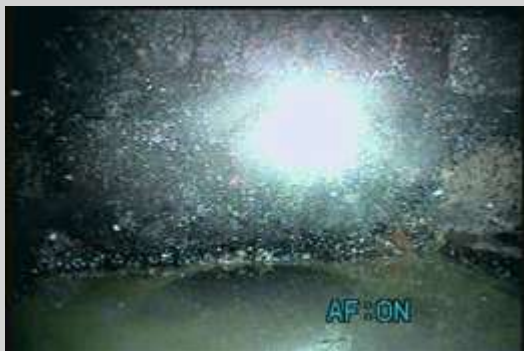
6 O'Clock Inflow

10 in. Circular Gravity Sewer
Pipe In @ 6 O'Clock

Invert Depth: **15.13** (ft.) Flow Characteristics: **Slow**

Deposits: ☒ None ☐ Mud ☐ Sludge ☐ Debris ☐ Grease

Infiltration: **None** Pipe Seal Cond: **Unknown**
